DEPARTMENT OF TRANSPORTATION

Contract #: 04-0120F4Cty: SF/ALA Rte: 80 PM: 13.2/13.9File #: 69.28**WELDING INSPECTION REPORT****Resident Engineer:**Pursell, Gary**Address:** 333 Burma Road**City:** Oakland, CA 94607**Report No:** WIR-015561**Date Inspected:** 13-Jul-2010**Project Name:** SAS Superstructure**OSM Arrival Time:** 700**Prime Contractor:** American Bridge/Fluor Enterprises, a JV**OSM Departure Time:** 1900**Contractor:** Zhenhua Port Machinery Company, Ltd (ZPMC), Changxing Island **Location:** Shanghai, China

CWI Name:	N/A	CWI Present:	Yes	No			
Inspected CWI report:	Yes	No	N/A	Rod Oven in Use:	Yes	No	N/A
Electrode to specification:	Yes	No	N/A	Weld Procedures Followed:	Yes	No	N/A
Qualified Welders:	Yes	No	N/A	Verified Joint Fit-up:	Yes	No	N/A
Approved Drawings:	Yes	No	N/A	Approved WPS:	Yes	No	N/A
				Delayed / Cancelled:	Yes	No	N/A
Bridge No:	34-0006	Component:	OBG Trial Assembly

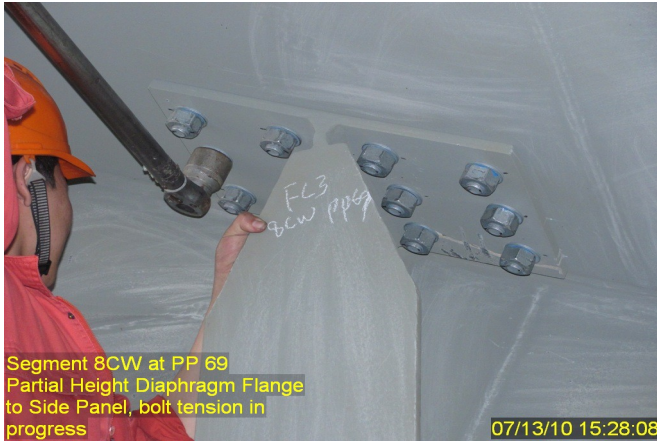
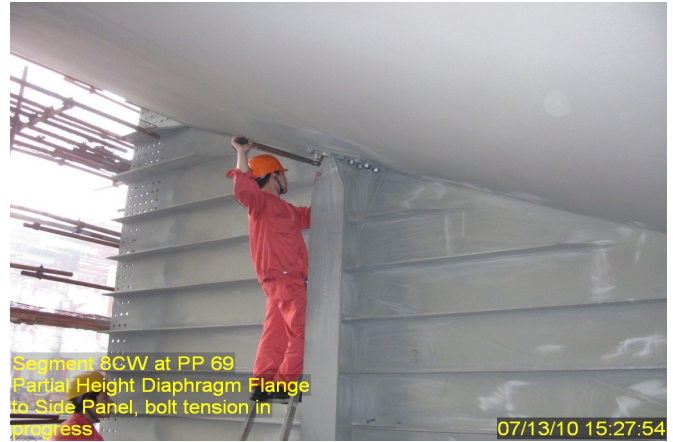
flange to the Side Panel at Panel Points (PP) 68, PP 69 and PP 70 for Segment 8CW. The QA Inspector verified the bolt tension on a random basis and the results appeared to be in general compliance. The Inspection was performed against Notification No. 00423.

The bolt sizes used were M24 x 65 RC Lot # DHGM240002 and the final torque value established was 573 N-m.

The manual torque wrench used to verify tension was S/N XO2-666. Please reference the pictures attached for more comprehensive details.
